DSTO-TR-0480

F-111C Lower Wing Skin Bonded  
Composite Repair Substantiation  
Testing

R. Boykett and K. Walker

**Airframes and Engines Division  
Aeronautical and Maritime Research Laboratory**

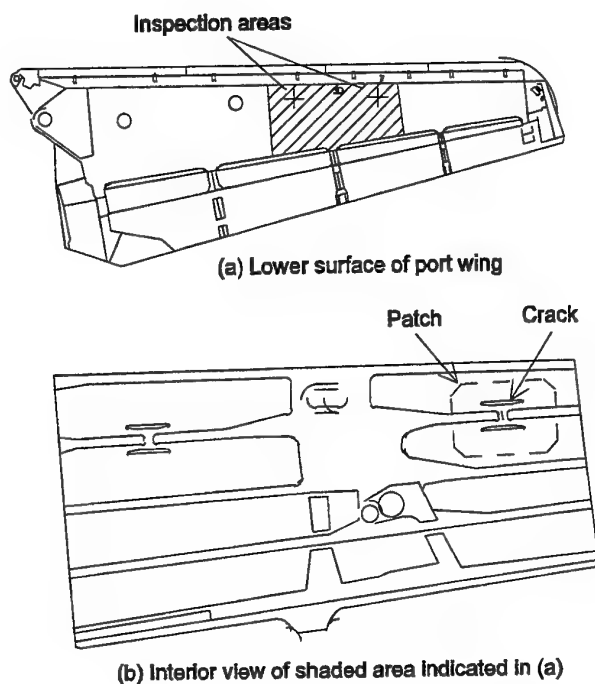
A crack was discovered in the port lower wing skin of a Royal Australian Air Force F-111C aircraft (RAAF tail number A8-145) during a routine visual inspection. The initial indication was fuel seepage at the site of an apparent 40 mm chordwise crack; however, a detailed non-destructive inspection revealed a through-thickness crack, 48 mm long tip-to-tip. Fracture mechanics calculations indicated that the residual strength had been degraded to 150 MPa (21.7 ksi), which is considerably less than the Design Limit Stress of 256 MPa (37.1 ksi) specified for this region of the wing<sup>1</sup>, compromising flight safety.

Figure 1 indicates the location of cracking on the lower wing-skin. Raised portions serve as integral stiffeners and as attachment lands for spars. The cracking occurred in an area lying below the forward auxiliary spar, at the spar station FASS 281.28, where the thickness of the integral stiffener is reduced from approximately 8.2 mm to the nominal skin thickness ( $3.7 \pm 0.1$  mm at this location). The purpose of this depression in the stiffener is to allow full fuel flow and drainage between adjacent bays of the

wing-box fuel tank. Two side-stiffeners compensate for the loss of spanwise stiffness due to this fuel-flow passage, as indicated in Fig. 1. The thickness variation in this region is more clearly illustrated in Figure 2. This asymmetrical geometry leads to a significant stress concentration factor and to out-of-plane secondary bending at the location where cracking occurs<sup>6</sup>.

Figure 1. Crack location on the F-111C lower wing-skin and repair patch outline.

A mechanically fastened metallic doubler repair option was rejected for a range of reasons, including undesirable aerodynamic implications and because the underlying structure could not be inspected. The only viable alternative to scrapping the wing was a bonded repair. A bonded boron fibre epoxy repair was designed and implemented by RAAF personnel, on the basis of design principles and application procedures developed by DSTO,<sup>2,3</sup> now incorporated by the RAAF into an Engineering Standard (C5033)<sup>4</sup>. Because the repair is to primary structure, comprehensive substantiation is needed to certify its airworthiness; Aeronautical and Maritime Research Laboratory (AMRL) is responsible for an independent validation of the repair design through Finite Element Modelling (FEM) and substantiation of the repair through representative specimen testing.

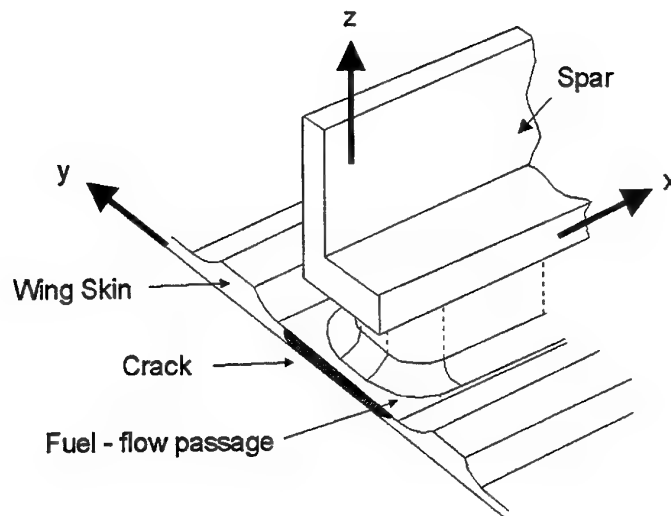
The cracking occurs in the chordwise direction, normal to the direction of the nominal principal stress from wing bending at that location. The presence of secondary bending loads results in the crack initially growing from the inside surface towards the outside surface with faster crack growth along the wing-skin's inner surface relative to its outer surface. This effect is clearly visible in the USAF specimen (refer to section 6). The discrepancy between the surface traces is further accentuated by the residual compressive stress at the outer surface caused by shot peening. For the purposes of assessing the residual strength, however, it is convenient to assume a straight-fronted through-crack, as indicated by the shaded area in Figure 2. This leads to the residual strength estimate of 150 Mpa.

Figure 2: Local geometry of the lower wing skin in the vicinity of the fuel-flow passage, showing the location of cracking and the coordinate axes used in the text.

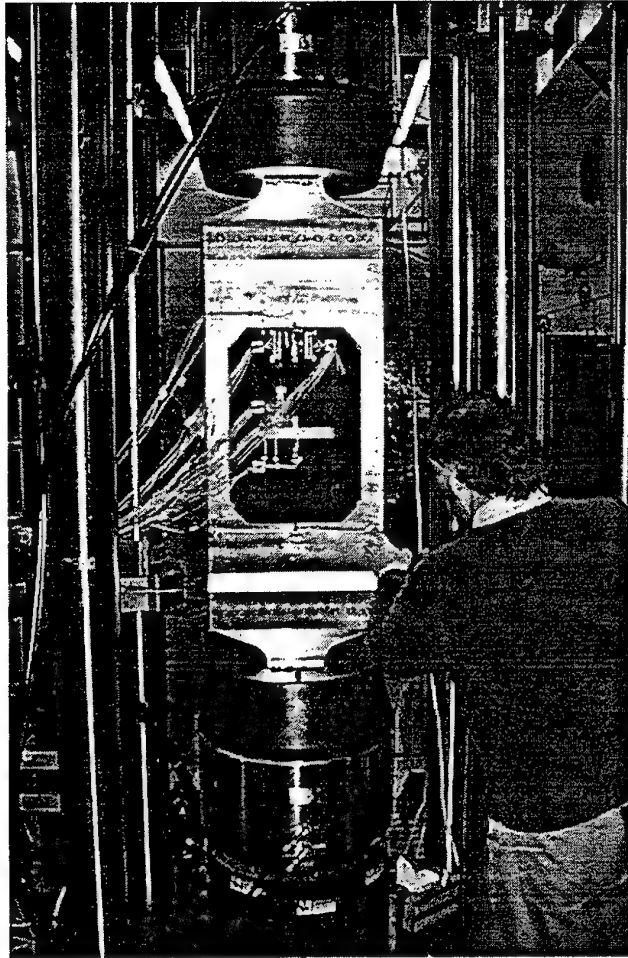
Figure 21. View onto side 1 of second box specimen in 2 MN testing machine showing strain gauge array and fracture line below end of patch.

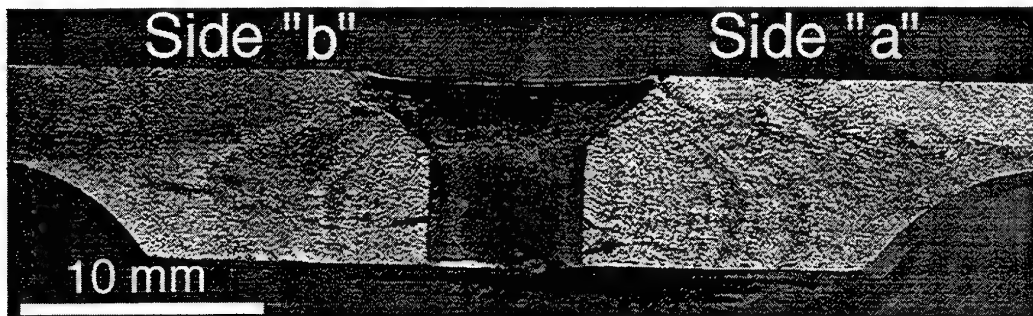
Under cyclic loading, there were two failures (one in panel *FLTP27-9* and one in the first box specimen) at the fastener hole immediately outside the end of the repair patch. Both were cyclic loaded under the blocked fatigue spectrum and both had clearance fit fasteners installed. The fracture surface of the box specimen is shown below in Figure 22 (the fracture surface of the panel is similar). The geometry of this part of the box specimen is similar to the repaired aircraft A8-145 - the patch terminates 10 mm from the centre of a 6.25 mm (nominal 0.25 inch) diameter, 100° countersunk, fastener hole. Note that there are different fasteners used ; clearance fit on the first box specimen and all the panel specimens, and interference fit on the second box specimen and the aircraft. The second box specimen also failed at this region during a static test to failure but there was no evidence of a fatigue crack initiating from any holes.

Figure 22. View onto fracture surface of first box specimen

Fatigue crack growth is clearly visible emanating from the bore of the fastener hole. A clearance fit fastener was used at this location and there is residual adhesive remaining in the bore (the fasteners were intentionally bonded in position). The crack proceeded to failure before it progressed past the end of the countersink. It was not detectable prior to failure, even with 45 degree angled eddy-current probe techniques. Similar sized cracks were evident at the other three similar fastener locations after the fasteners had been removed.

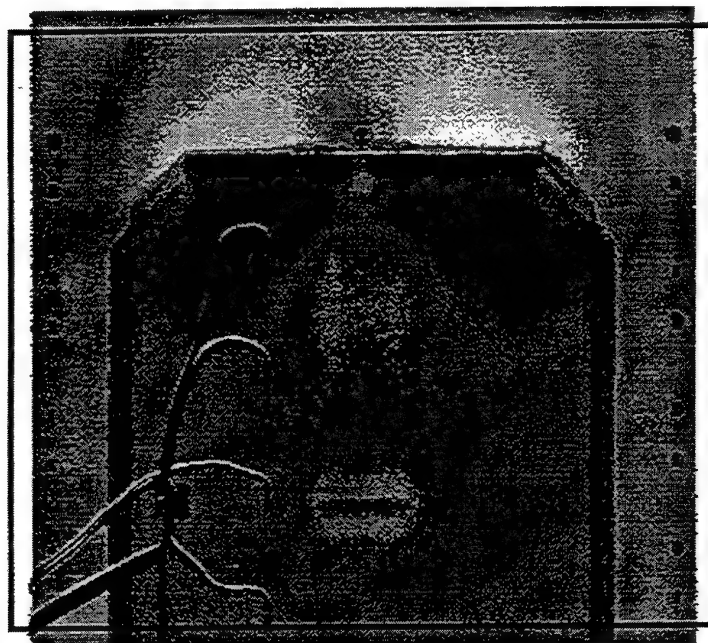
*Figure 23. FAST scan - View onto Box 1, skin 2 repair patch after 800 equivalent flight hours. Spanwise load axis is vertical in this view. Lighter shaded areas have higher levels of surface strain.*

The increased strains are clearly evident in the central region in the lower part of this view, where the crack location is shown by the darker line. The fastener location adjacent to the end of the patch is in an area of unusual strain distribution ; a small

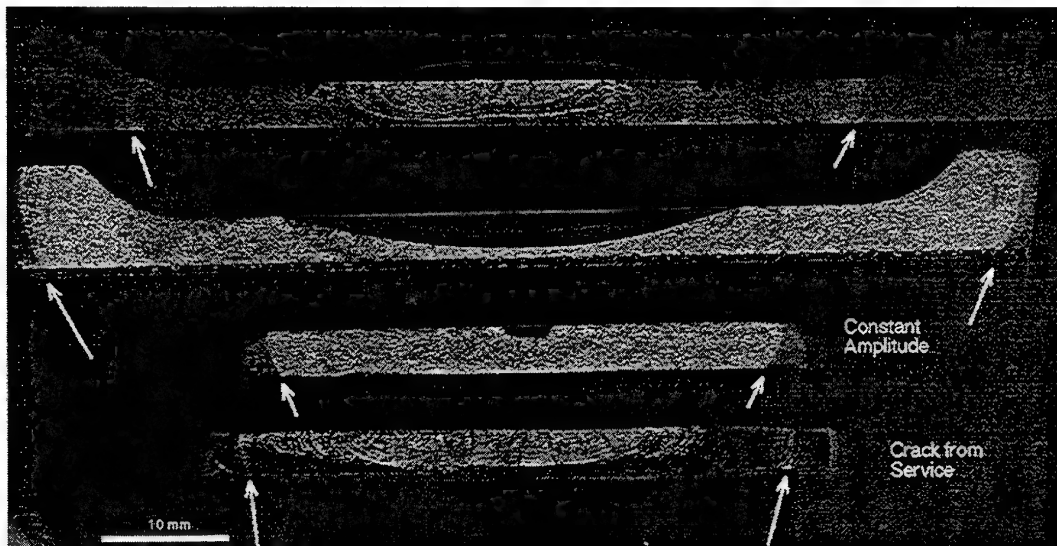
A comparison of the fracture surface of the USAF specimen and three of the AMRL panel specimens is shown in Figure 24. The crack front can be clearly seen growing from multiple initiations on the inner surface which join into a semi-circular crack. After breaking through the outer surface it becomes a through crack approximately 40 mm long. A replica of the final through crack can be obtained in test specimens by the introduction of a semi-circular EDM notch followed by constant amplitude cyclic tension loading. The multiple initiations for the crack were evident in panel specimens, that had no EDM notch, loaded under the cycle-by-cycle spectrum<sup>19</sup>.

Figure 24. Fracture surfaces (from top down)

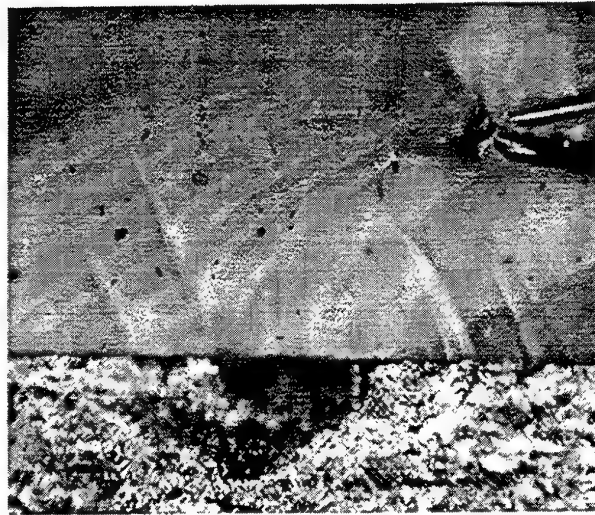
The fracture mode of panel specimens was often a clean fracture of the repair patch (no delamination) adjacent to the fracture in the aluminium adherend. Fractography shows crack growth in the adhesive very similar to that in the aluminium adherend (in Figure 25 below), but cannot determine what the failure sequence is between fibre fracture, adhesive disbonding/fracture, and cracking in the aluminium adherend. It is proposed that the crack growth in the aluminium matches that in the adhesive, since the final fracture tear begins at exactly the same place in both materials<sup>22</sup>.

Figure 25. Crack growth in adhesive layer.

*The crack front is parallel to progression lines and perpendicular to chevrons. (aluminium shown darker, in lower third of picture, below interface).*
